# CHOPPER-CONTROLLED DISCHARGE LIFE CYCLING STUDIES ON LEAD-ACID BATTERIES

## FINAL REPORT

by Joseph J. Krami and Ernest P. Ames  
TRW SPACE AND TECHNOLOGY GROUP

**APPENDIX A**  
**EV-106 LEAD-ACID BATTERY FAILURE NO. 16 (S/N 097)**  
**SAMPLE REPORT**

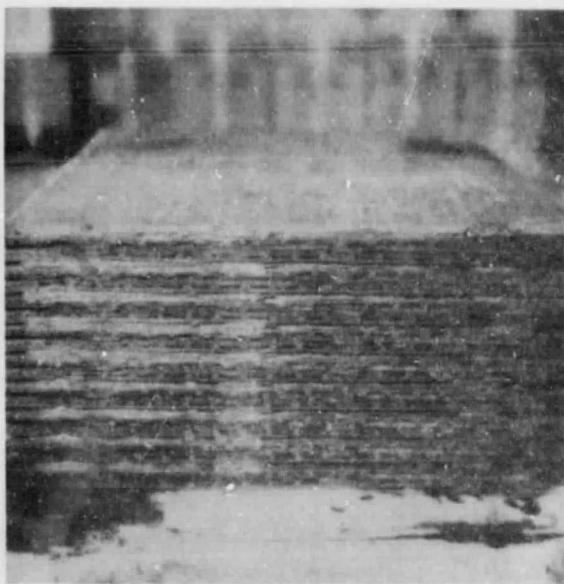
Visual inspection of the element from Cell No. 1 revealed slight "mossing" on all sides. Figure 1 shows the "mossing" on the bottom surface of the element from Cell No. 1. However, no "bridging" was observed.

Figure 1. "Mossing" on the bottom surface of the element from cell No. 1.

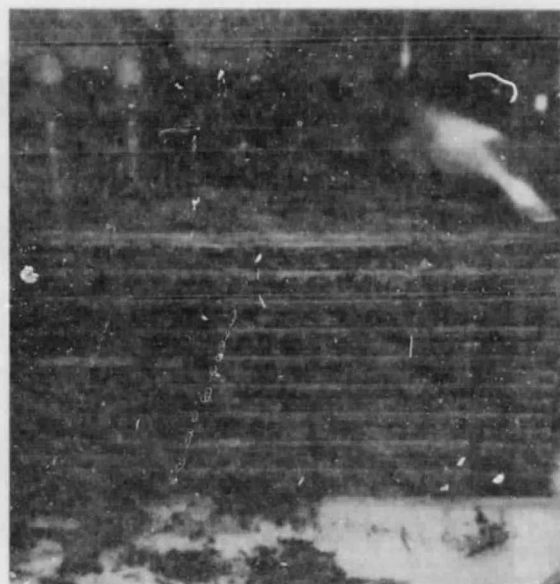
Visual inspection of the element from Cell No. 2 revealed very little, to almost no mossing on all surfaces, except for one of the side surfaces. Figure 2 shows the bottom surface of the cell element. Notice that very little "mossing" was observed. Figure 3 shows severe "mossing" on one of the side surfaces. Figure 4 shows negative active material contacting the top positive plate (P-1) on the side of the cell element shown in Figure 3. Figure 5 shows the side surface of the cell element after it was partly disassembled. Notice on the same figure the "bridging" between positive and negative plates.

Figure 2. Very little "mossing" on the bottom surface of the element from cell No. 2.

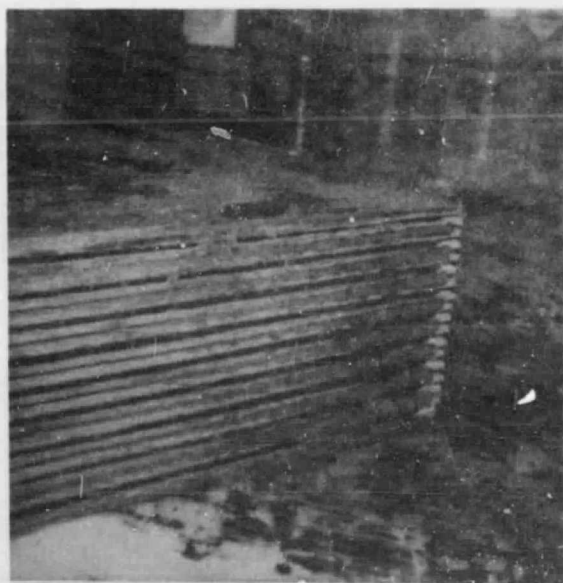
Figure 3. "Mossing" and "bridging" on one of the side surfaces of the element from cell No. 2.

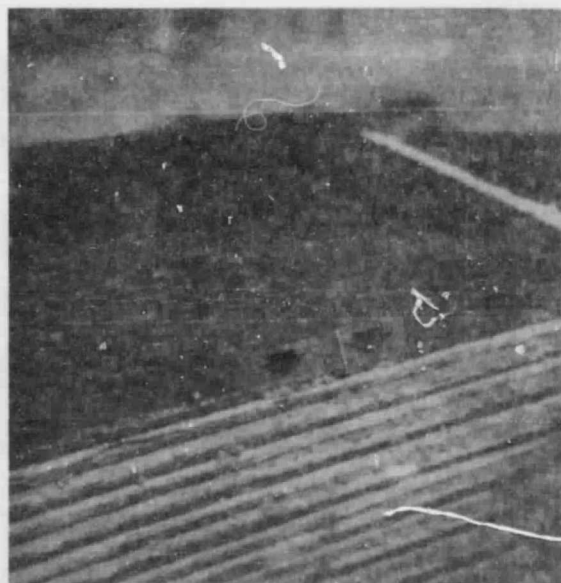
Figure 4. Negative active material beachheads on the positive plate (P-1) from cell No. 2.

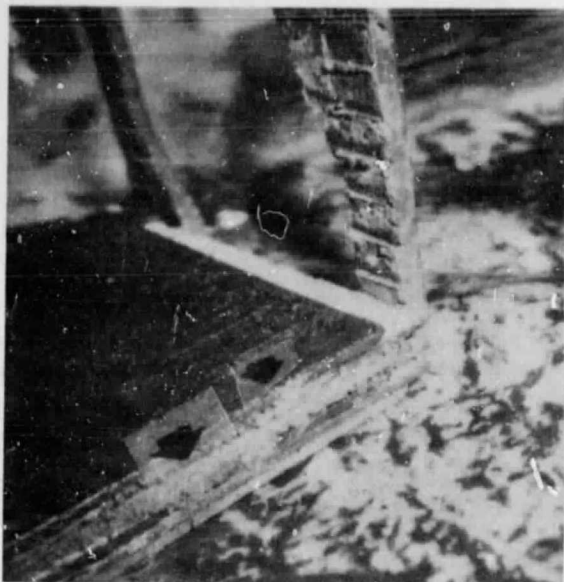
Figure 5. "Bridging" between positive and negative plates in cell No. 2.

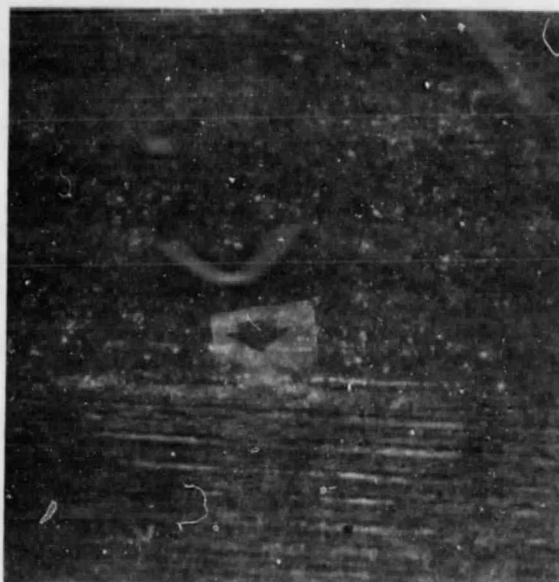
Figure 6. "Bridging" between positive and negative plates in cell No. 3.

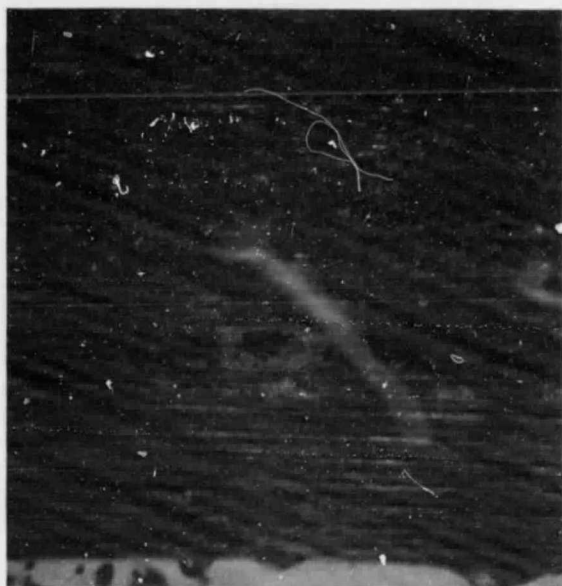
Figure 7. Top plates and separators removed to reveal more "bridging" in cell No. 3.

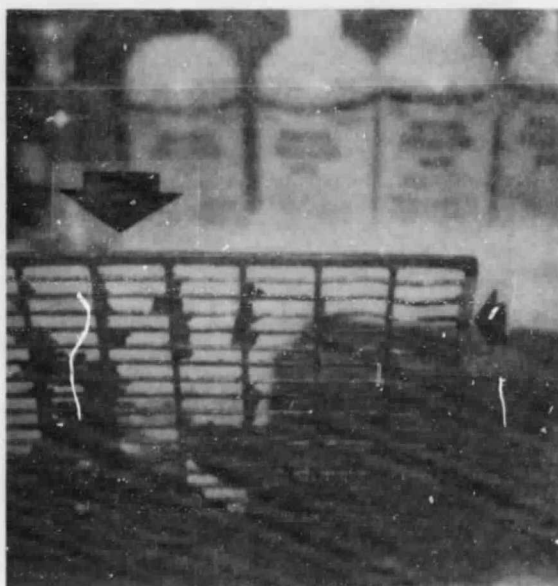
Figure 8. Spalling in plate (P-5) from cell No. 1.

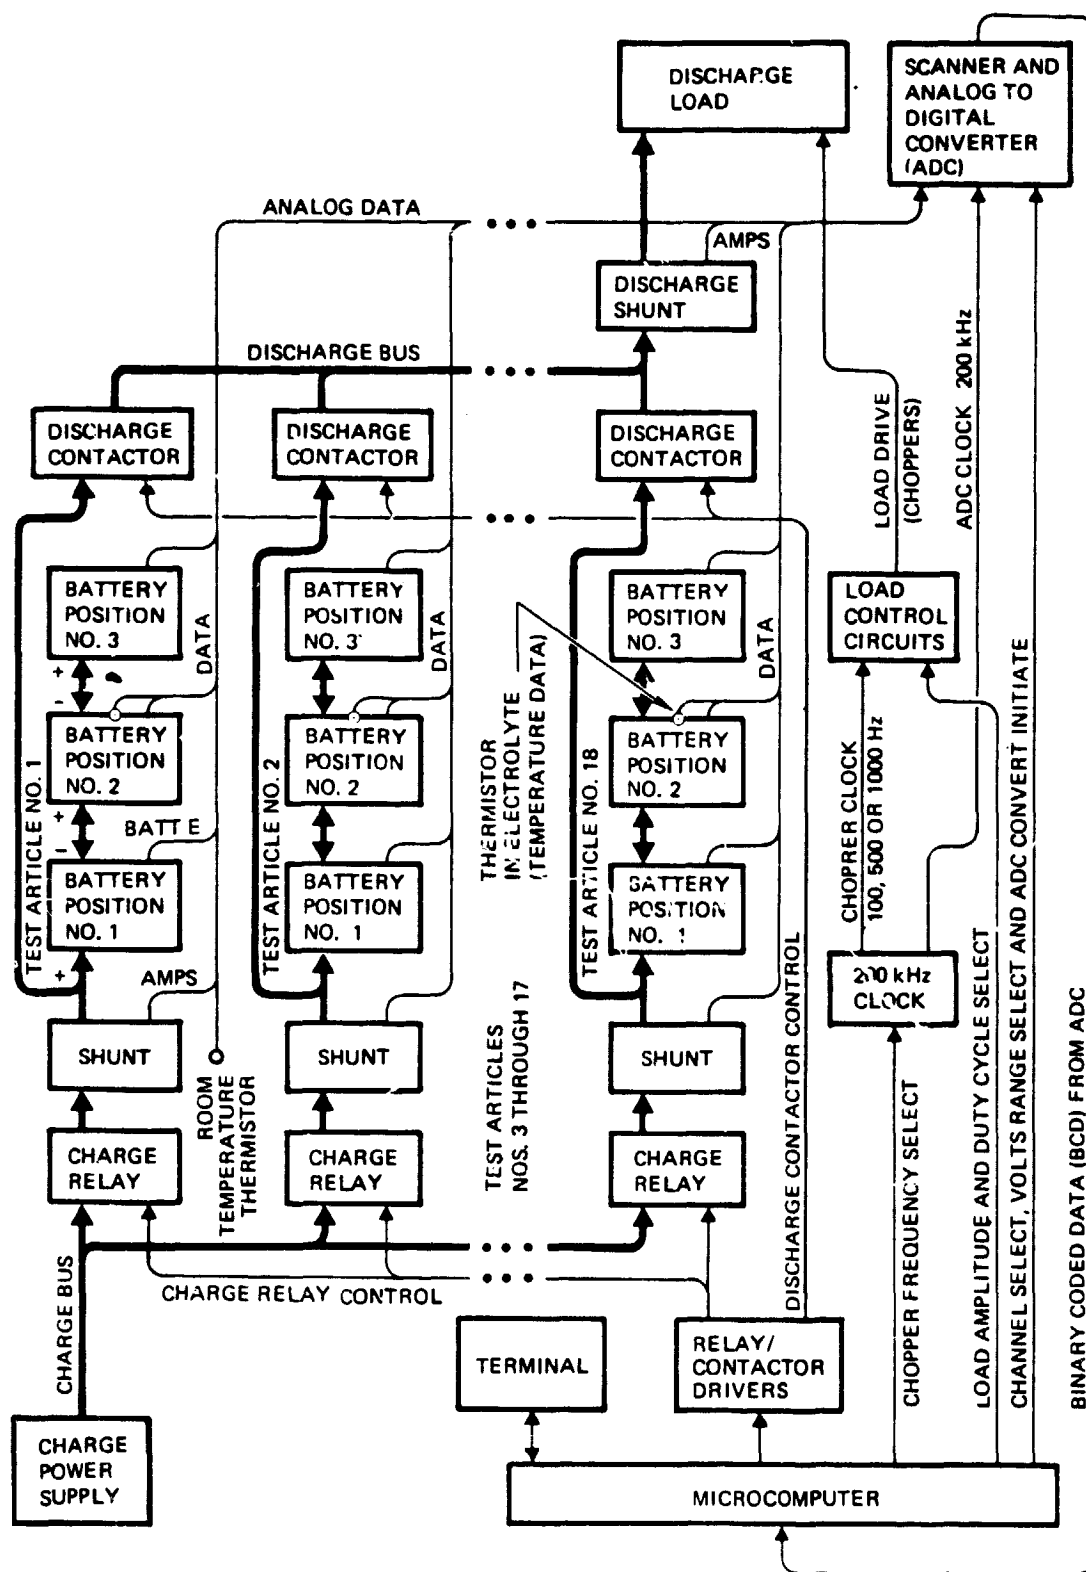
Figure 1. EV-106 Lead-Acid Battery Test System, Functional Block Diagram

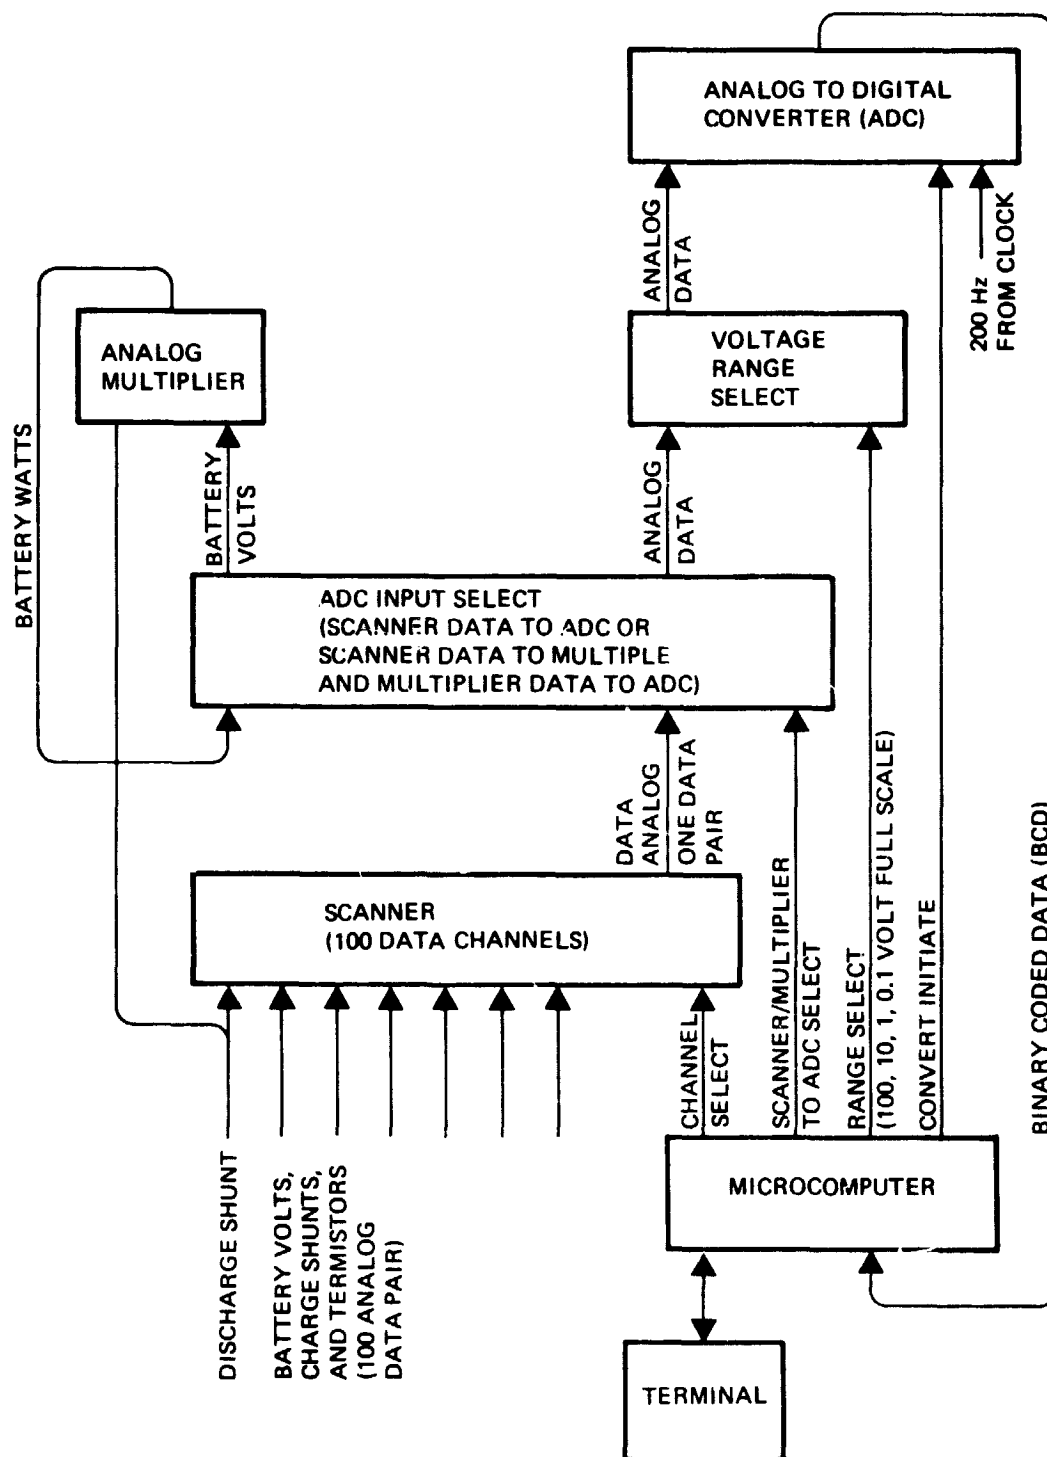
Figure 2. EV-106 Lead-Acid Battery Test, Data System Block Diagram

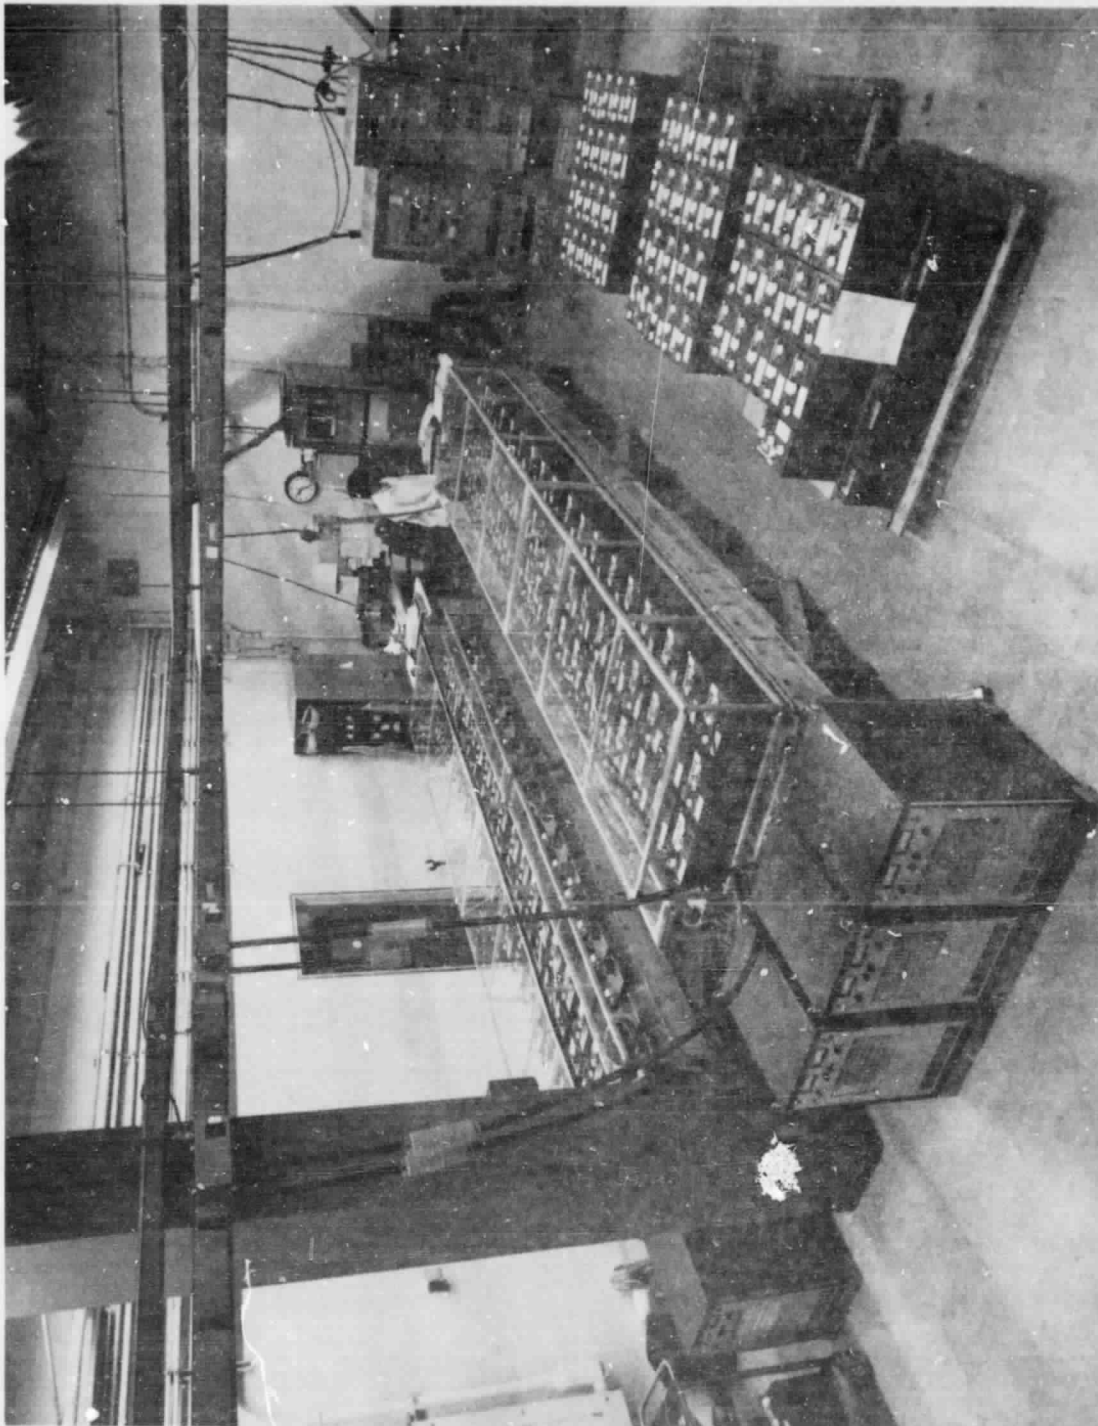
Figure 3. Test Facility, Overall View

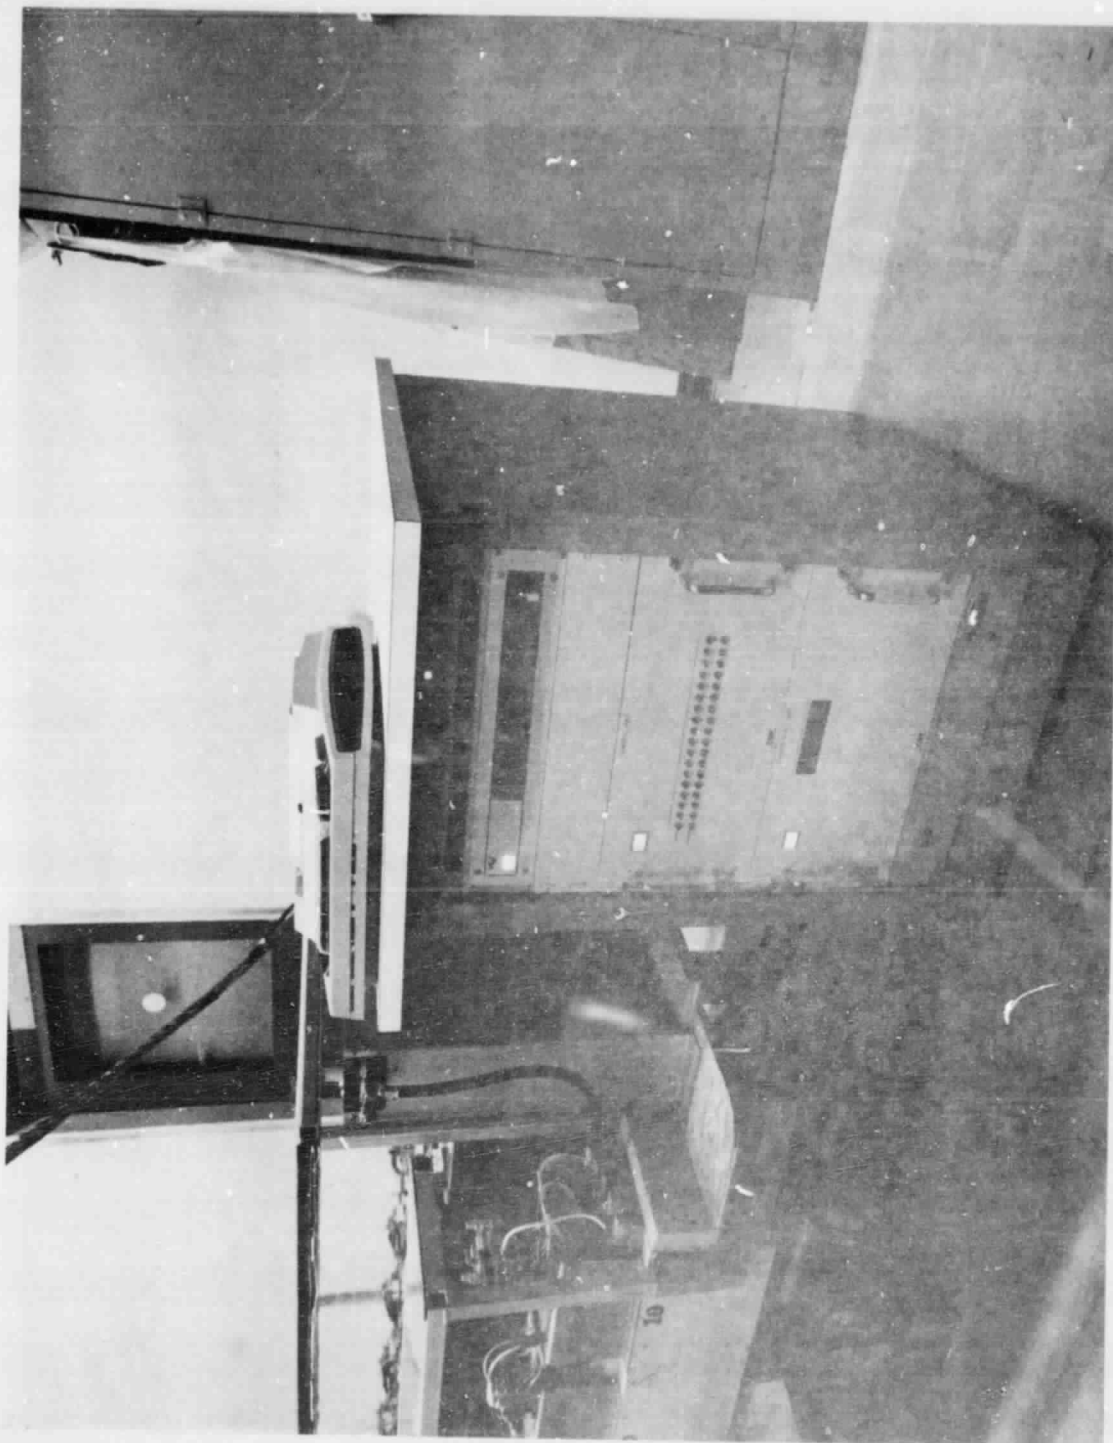
Figure 4. Test Data System, Microcomputer and Printer for System II

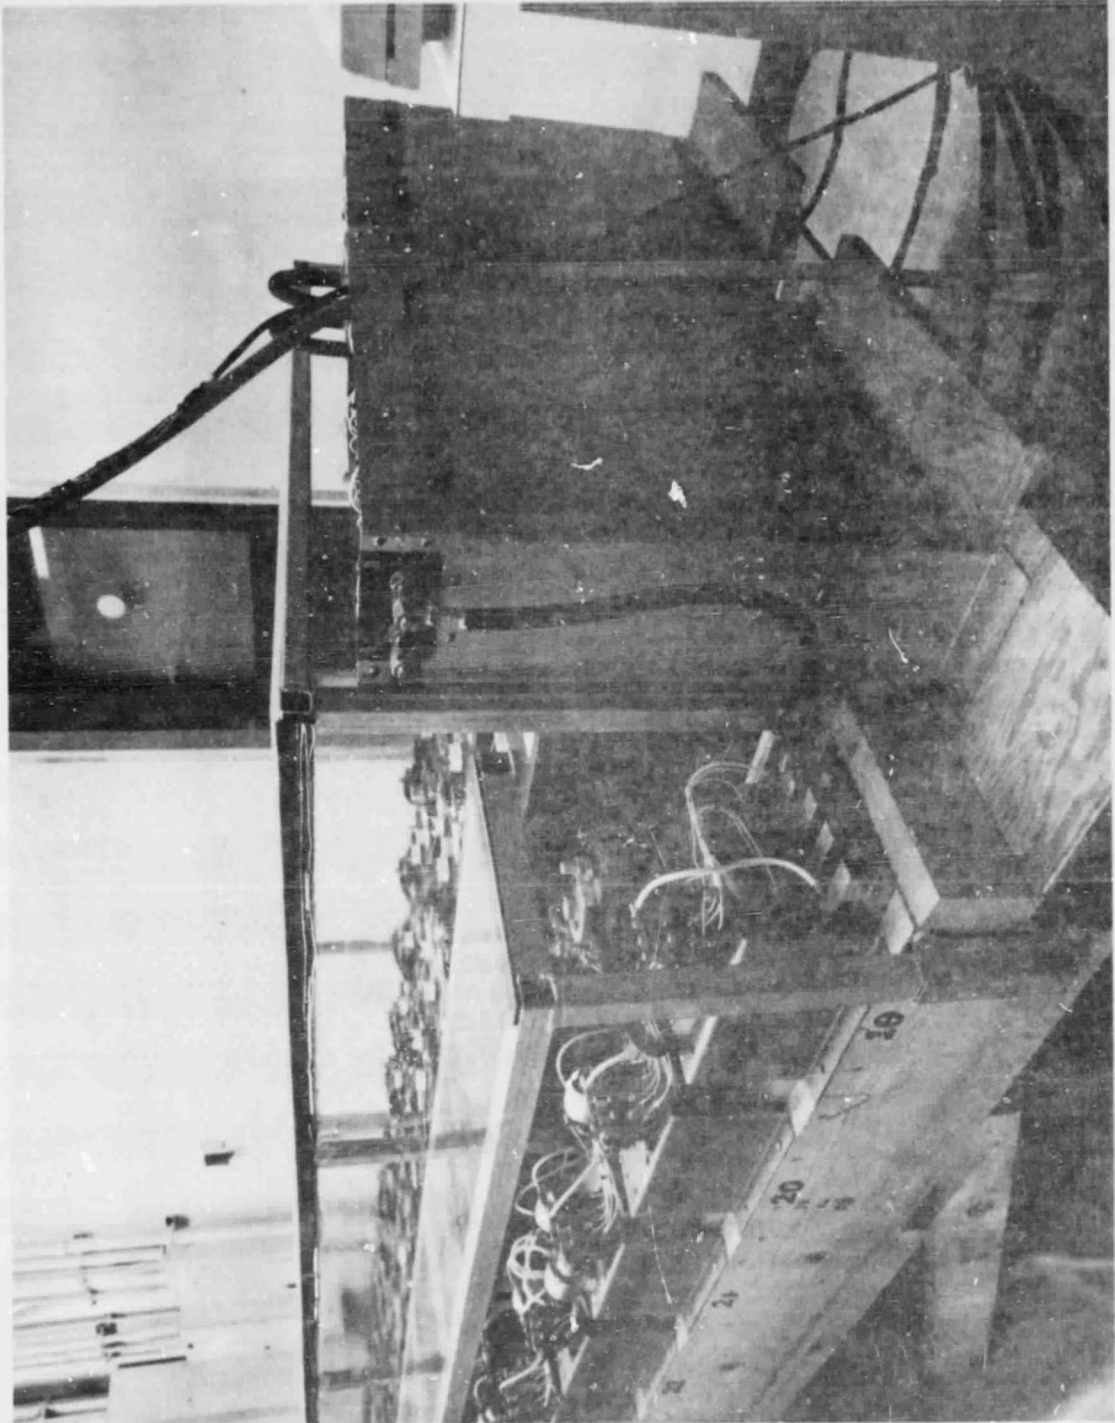
Figure 5. Test System II Load Banks and Control Elements  
for Test Articles 19 through 22

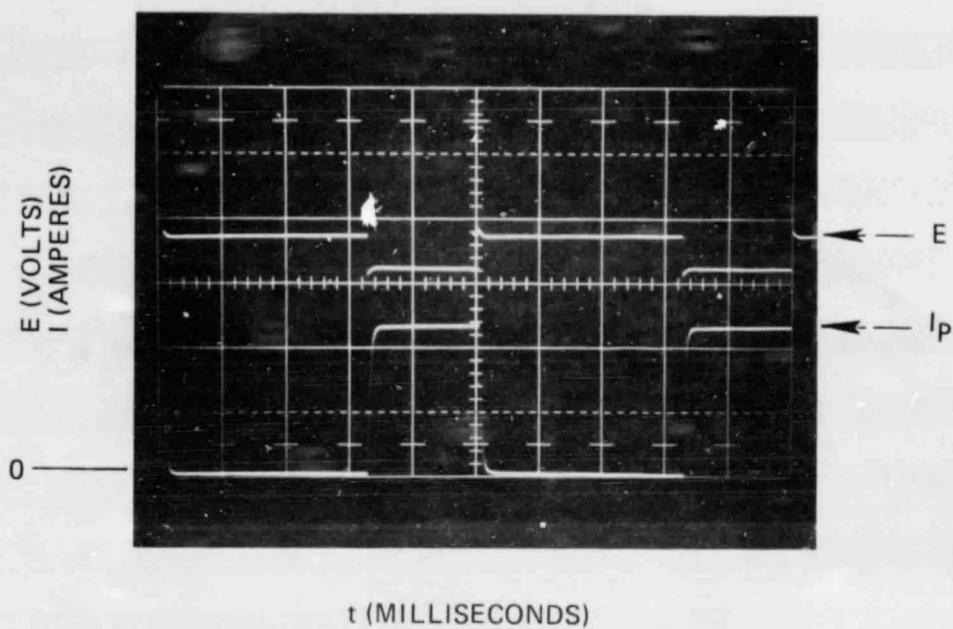
SCALES: E = 5V/DIV.  
I = 125 AMP./DIV.  
t = 0.4 MS/DIV.

AVERAGE CURRENT	= 100 AMP.
CHOPPER FREQUENCY	= 500 HZ
CHOPPER DUTY CYCLE	= 35%

Figure 6. Test Article 25 Discharge Current and Voltage Waveforms

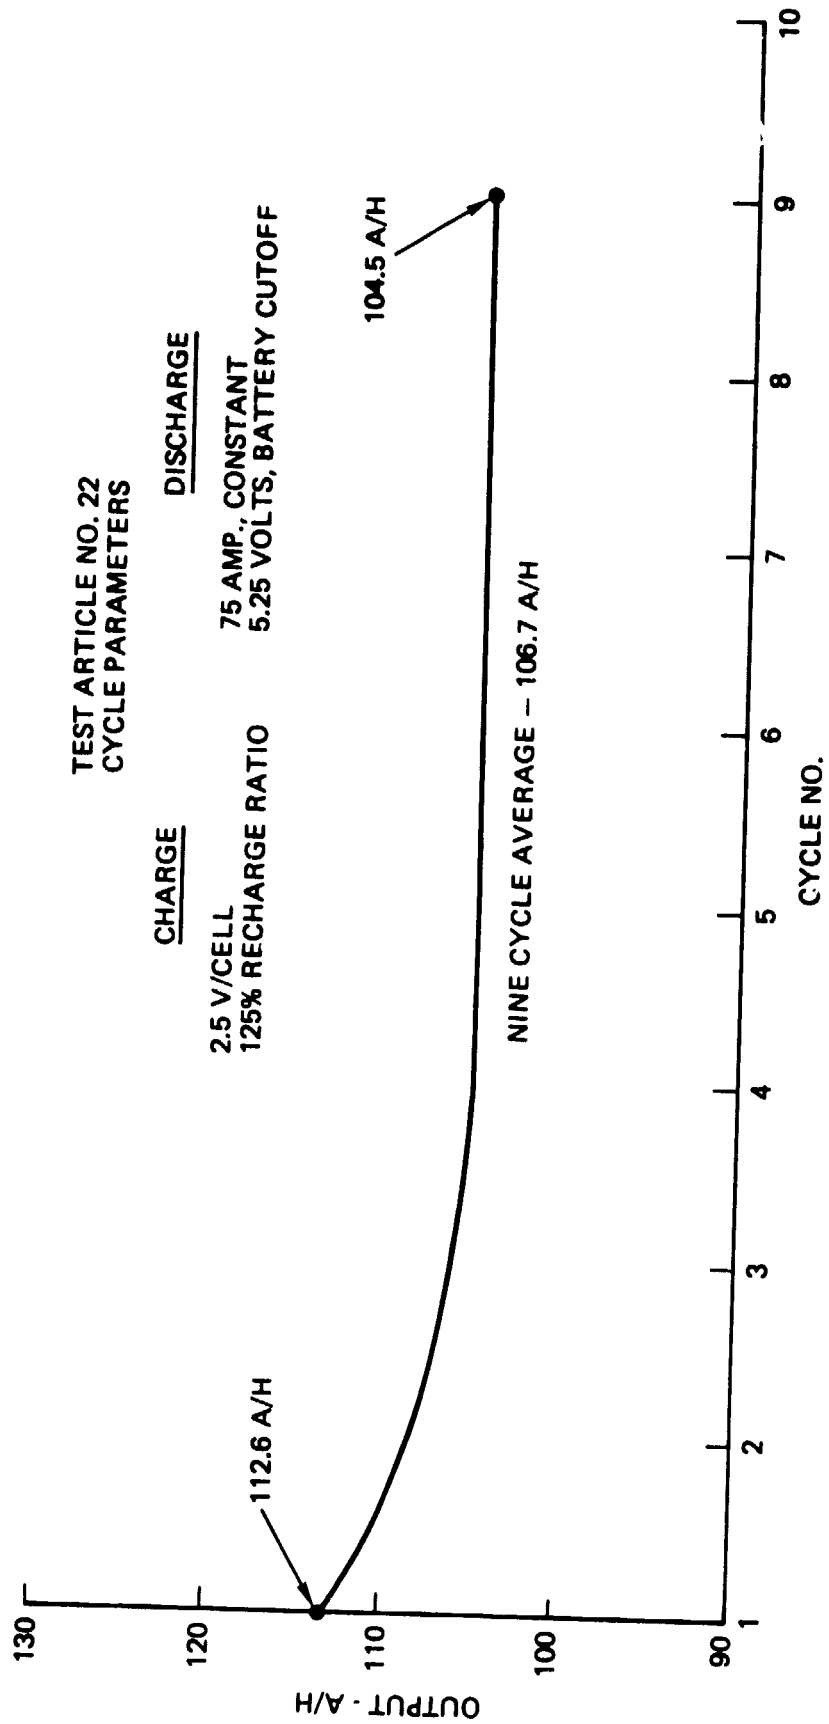
Figure 7. Acceptance Test, Capacity Discharge Output  
Typical for Nine Cycles

The manufacturer's rated capacity of 132.5 ampere-hours at a 75-ampere rate was never realized during the standard acceptance test. Capacity values ranging from 118 to 106 ampere-hours were obtained over eight and nine successive discharge and charge cycles for an average value of 107 ampere-hours. Acting upon the manufacturer's recommendation to use an overcharge factor as high as 30 percent, increasing recharge input values of from 111 to 130 percent were tried but had little or no effect upon the output capacity. By mutual agreement with the NASA Program Manager, a recharge value of 125 percent was used for the capacity tests. A typical set of capacity values obtained for nine cycles using a 125 percent recharge factor is shown in Figure 7. Battery discharge cutoff voltage was 5.25 volts. Electrolyte specific gravity at the end of recharge averaged 1.275 at an average temperature of 22°C. Specific capacity output values obtained for all batteries are shown in Table V. It can be noted from this data and Figure 7 that capacity output drops rapidly during the first three cycles and remains fairly constant for the remaining cycles.

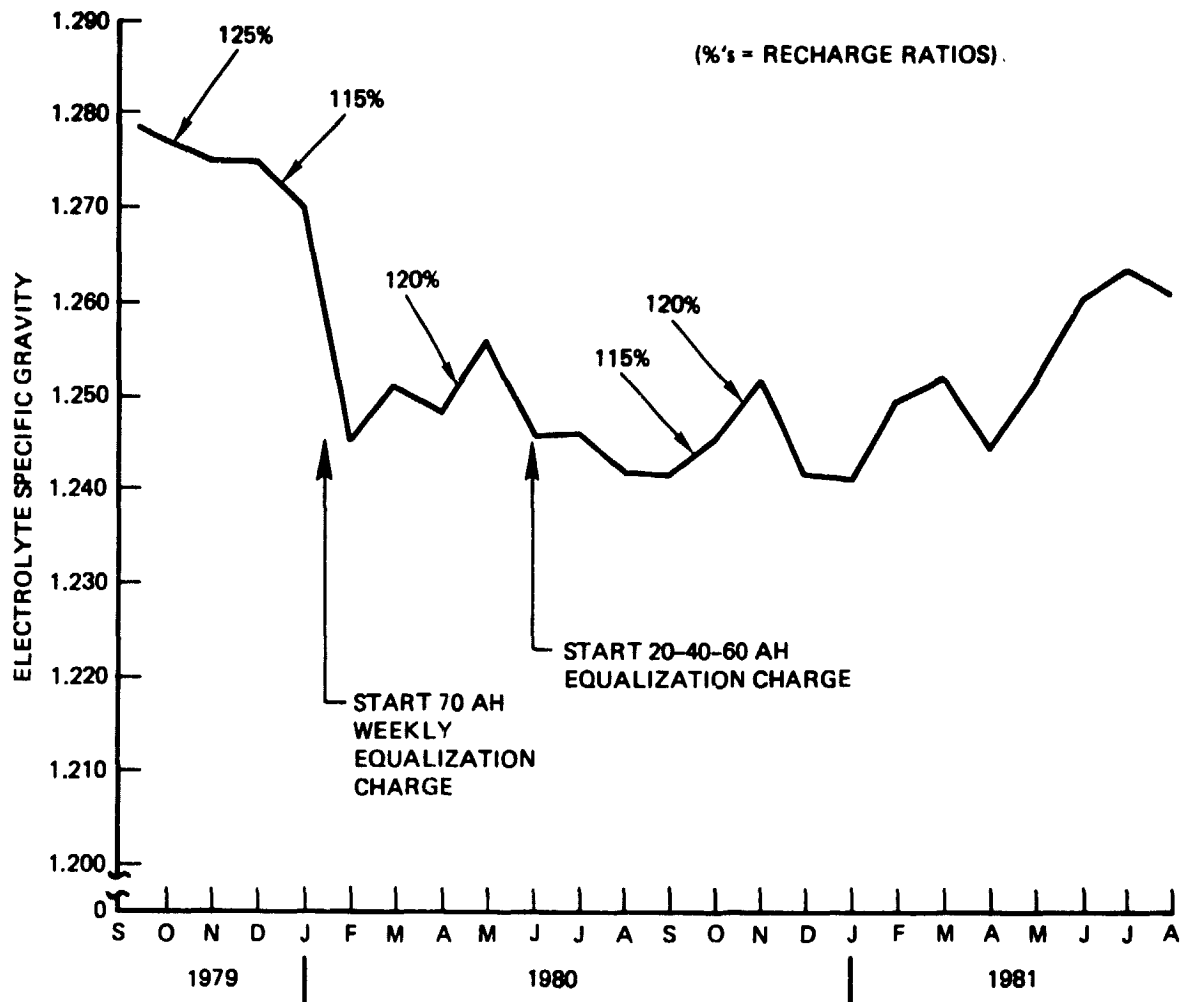
Figure 8. Specific Gravity Monthly Averages of all Test Batteries

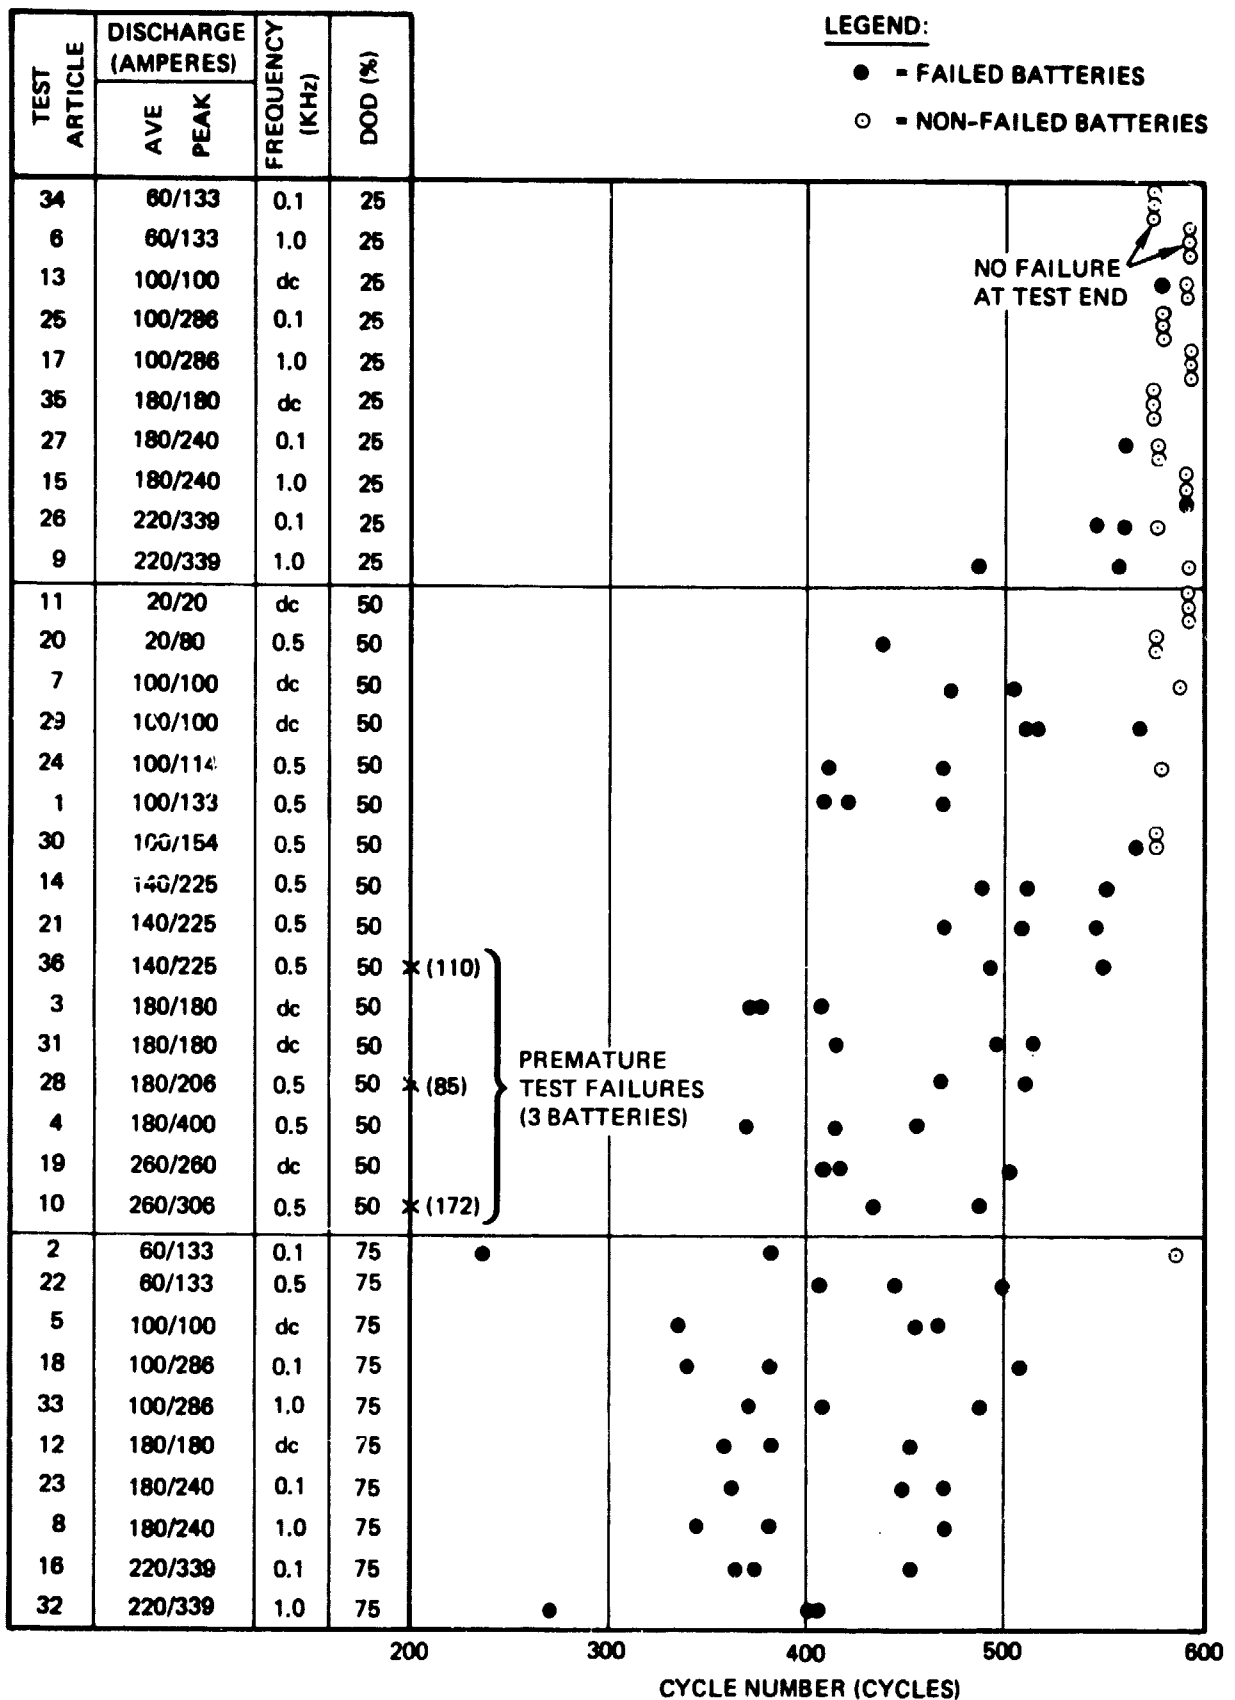
Figure 9. EV-106 Lead-Acid Battery Life Test, Charge/Discharge Cycles to Failure

Figures 9 and 10 illustrate the above findings. Individual battery failure points and unfailed batteries' final cycle are depicted.

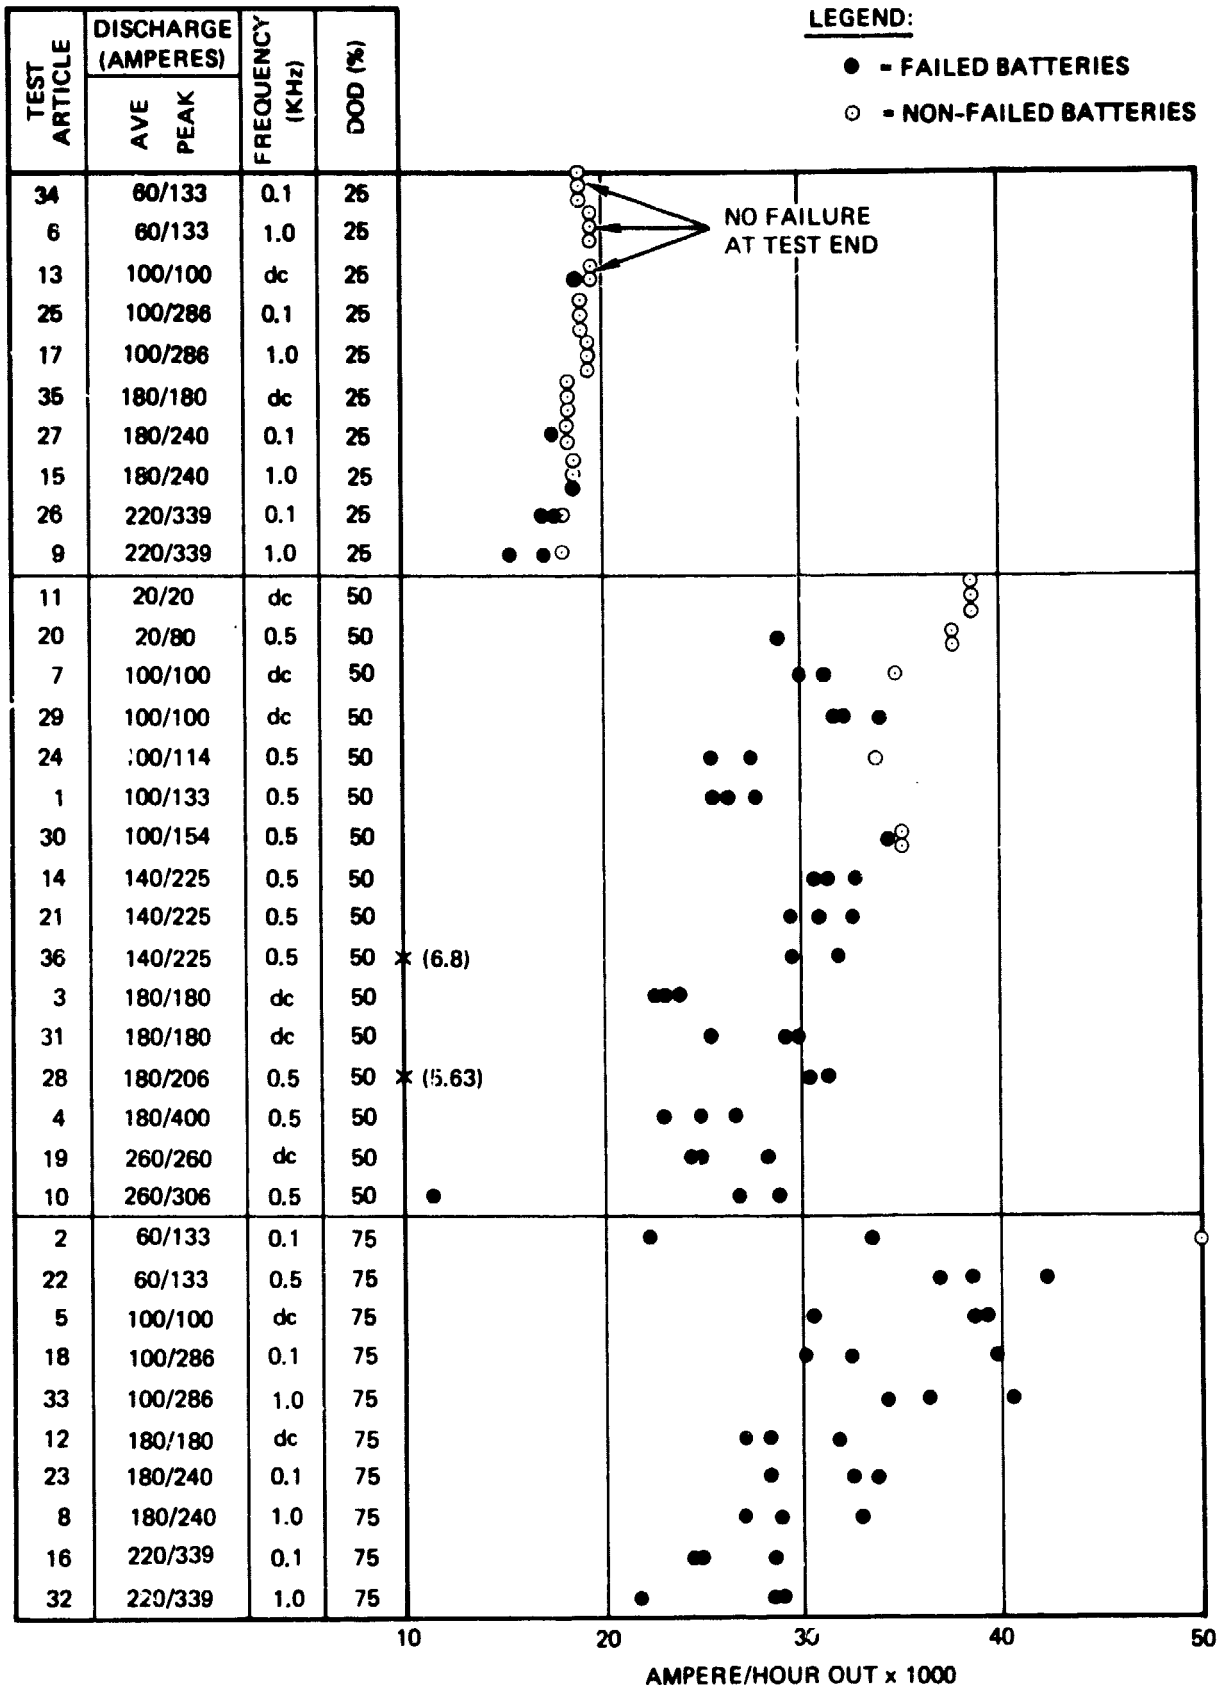
Figure 10. EV-106 Lead-Acid Battery Life Test, Ampere-Hours Out to Failure
